U.S. 101 MP 142.48 HARLOW CREEK (WDFW ID 990548): Preliminary Hydraulic Design Report

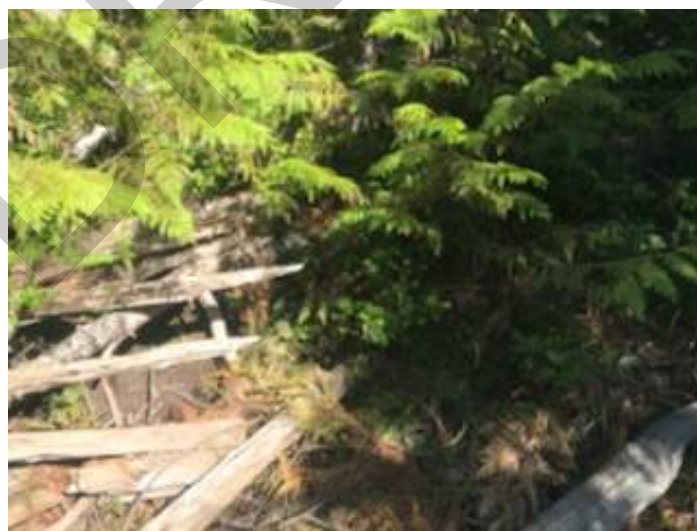
Figure 8: Large Woody Material (LWM) from historic logging

The active floodplains are accessible, flat, and narrow; they are also terraced and slope up to a second floodplain that appears accessible only under extreme flood events. The large accumulation of logs in the upper mainstem channel are most likely the result of historic logging activities (Figure 8). At the confluence of the left bank UNT and mainstem, an accumulation of logs and fine sediment deposits were observed.

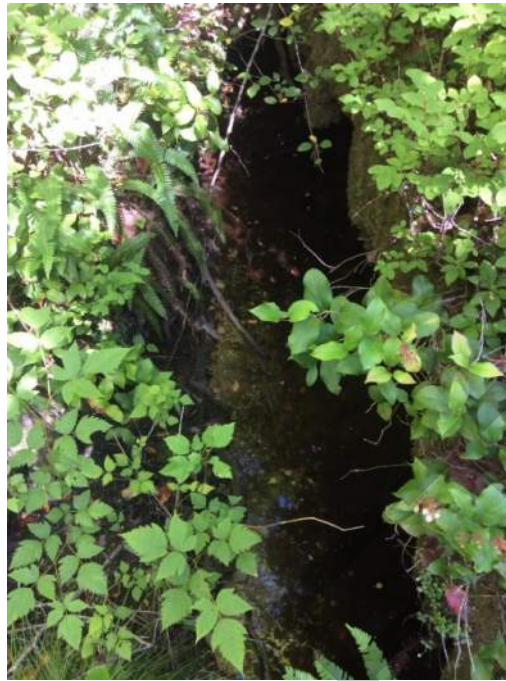
Figure 11: Typical UNT channel view with approximately 3-foot-high banks

approximately 3 feet in height and the floodplains appear inaccessible (Figure 11). As the UNT approaches the confluence with Harlow Creek, flow follows the undulating bed surface under and around LWM and a large stump.

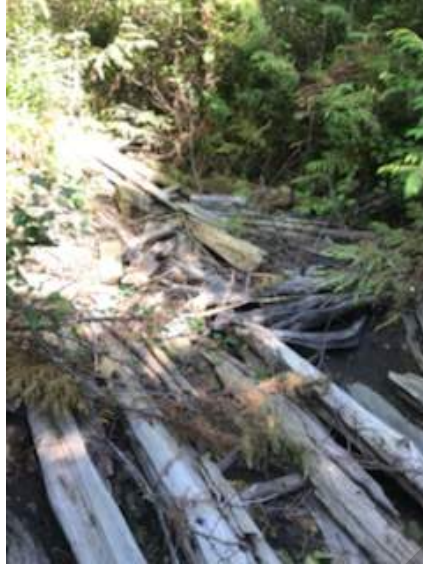
Figure 12: Abundant LWM suggesting historical logging activities

At the approximate location where the UNT and Harlow Creek meet, an island is present in the middle of the Harlow Creek channel. Trees grow out of the island in the middle. Small gravels and a few cobbles are present on either side of the island. There is a multitude of wood in the channel, all indicative of historical logging activities (Figure 12). Both banks are approximately 3 to 4 feet in height and are near vertical, and the channel substrate is dominated by the presence of fines.

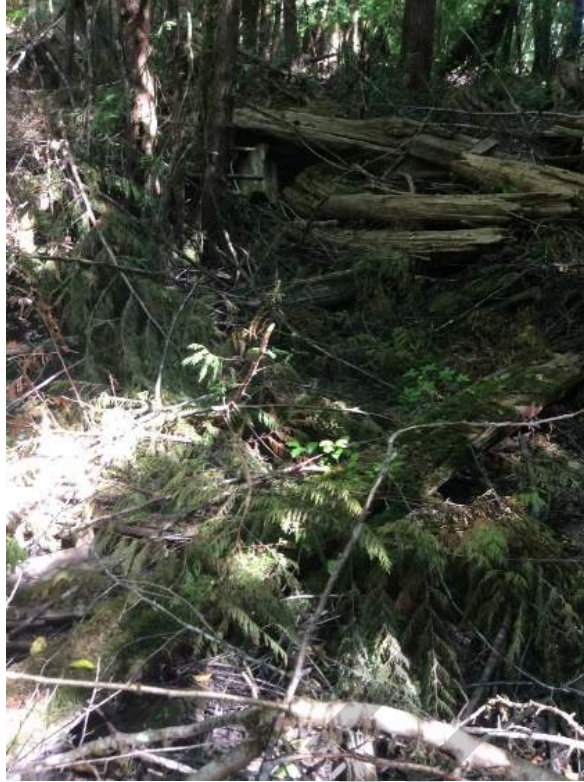
Figure 16: LWM accumulation near exit of pool

Farther downstream, there is a pool approximately 30 to 40 feet in diameter (Figure 15). LWM from logging activities is present in the pool and racked up at the downstream end towards the right bank (Figure 16). This wood appears to be stable and somewhat decomposed, with no evidence of recent movement. The substrate of the pool is entirely fines, and the floodplains are accessible to streamflow.

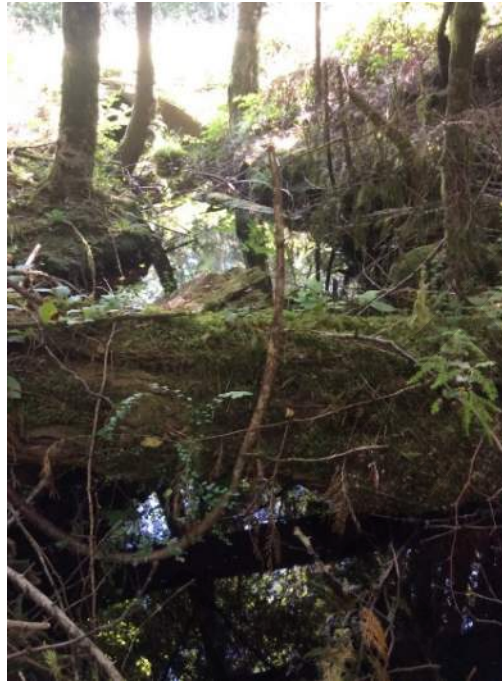
Figure 18: Stream conditions between LWM and inlet

The substrate from this section downstream to the culvert inlet is primarily gravels. Approximately 50 feet upstream of the culvert inlet, LWM recruited naturally from the banks is present in the channel and forming accumulations that span the channel between both banks (Figure 18). Valley occlusion has led to some areas where logs are quite dense and accumulating soils, supporting tree and shrub growth, which the stream flows and pools beneath. The area is characterized by a complex of multiple flow paths and sloughs.

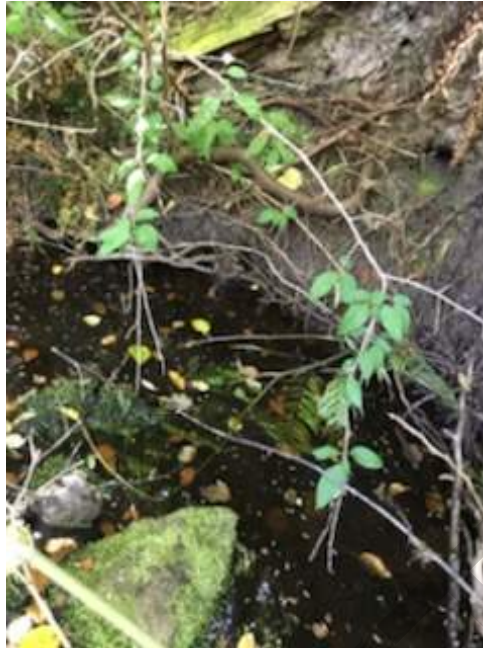
Figure 19: Bank erosion near culvert inlet

The channel shape in this area consists of short vertical banks that slope up towards a flat floodplain. The banks are undercut in the proximity of the culvert and confine the channel in a straight, entrenched planform (Figure 19). Flow contraction due to an undersized culvert is likely driving localized channel bed and bank erosion at the existing inlet. Naturally recruited logs provide a degree of bank stability in the area between the racked-up wood and the culvert. On the right bank near the culvert, a small side channel enters the stream. It likely carries floodplain flow from upstream to this location. There is LWM present in the side channel.

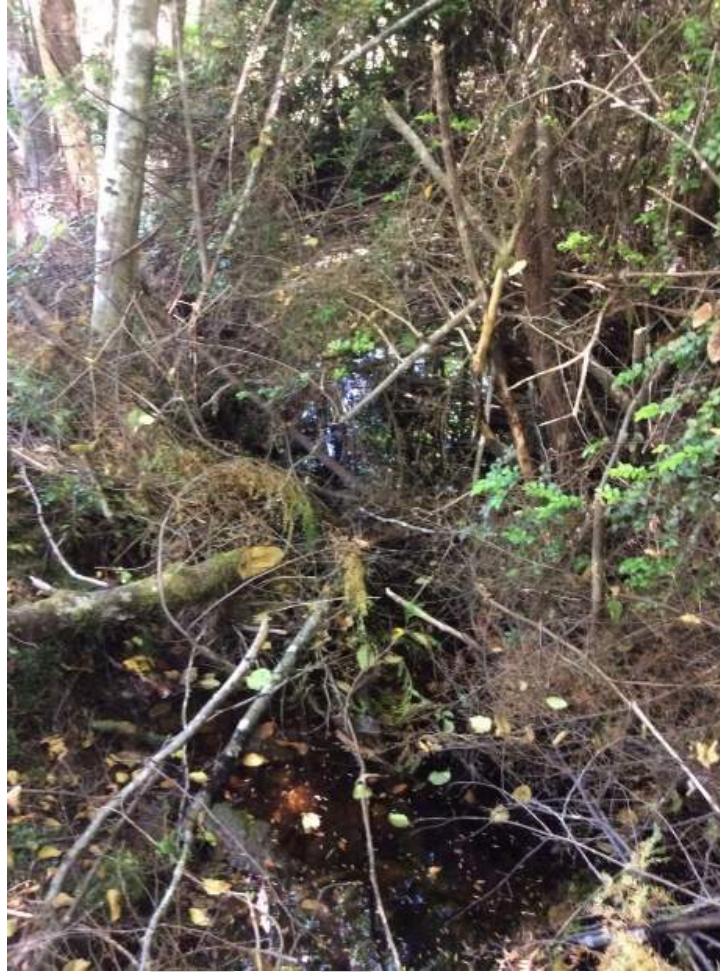
Figure 22: Brush and debris in channel

The right bank is about 3 to 4 feet tall, while the left bank is lower with an accessible inset floodplain surface. Stands of young trees and ferns grow on the banks. Some undercutting of the channel bank is present at a bend downstream of the rip rap. Small debris and brush are racked up after this bend, throughout the whole of the downstream reach. All debris within the channel appears to be a result of natural recruitment, though the pieces and accumulations are not stable enough to provide a lasting influence on channel form or processes (Figure 22).

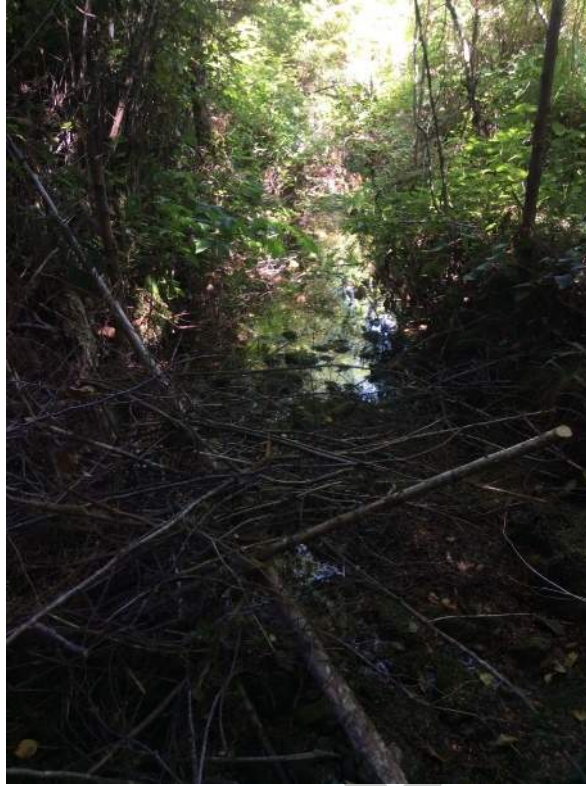
Figure 26: Typical channel conditions downstream of reference reach

Downstream of the reference reach, the channel shape changes to become narrower and deeper with inaccessible floodplains (Figure 26). Both banks are 3 to 4 feet in height and show signs of erosion due to channel incision (Figure 27). The banks are vegetated with brush and trees, and the substrate is gravels and cobbles.

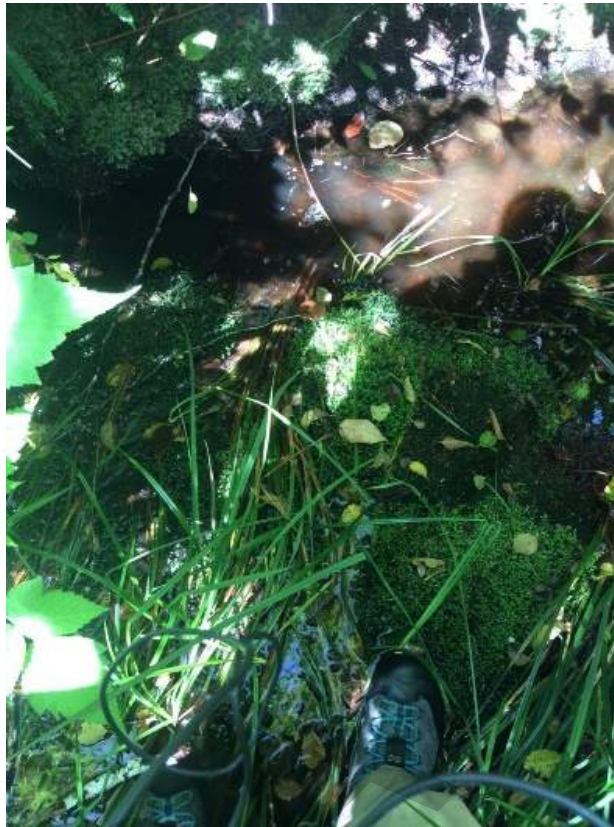
Figure 28: WS drop over sedge

Approximately 30 feet before the end of the survey extents, there is a 6-inch water level drop over sedges and sediment present in the channel (Figure 28). At the very downstream end of the survey, the

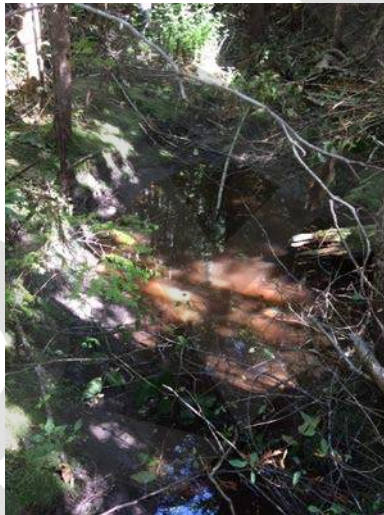
Where the flow converges on the downstream side of the island, there is a large log jam consisting of logs associated with historic timber harvest. Downstream of the jam, the channel narrows to approximately 5 feet wide. The substrate is mostly fines with some gravels and cobbles. Sedge and brush grow in and over the channel in this reach. The bank slopes are gradual and about 2 feet tall, made of soft material. Stands of young trees grow on the banks. The banks are undercut, and the floodplains are flat and accessible (Figure 10 and Figure 11). Natural logs help form and shore up the banks periodically.

Figure 10: Stream conditions downstream of confluence

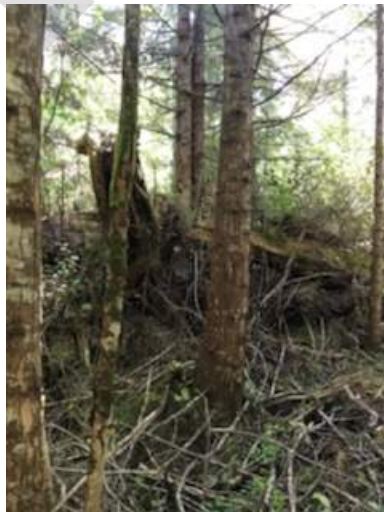
Figure 11: Floodplains downstream of confluence

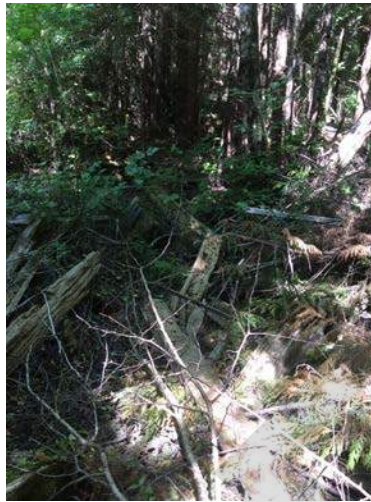
The channel reaches a large, flat, bowl-like pool, approximately 30-40' in diameter (Figure 12). LWM from logging activities is present in the pool and racked up at the exit of the pool towards the right bank (Figure 13). The substrate of the pool is entirely fines, and the floodplains are accessible to the pool.

Figure 12: Large undefined bowl

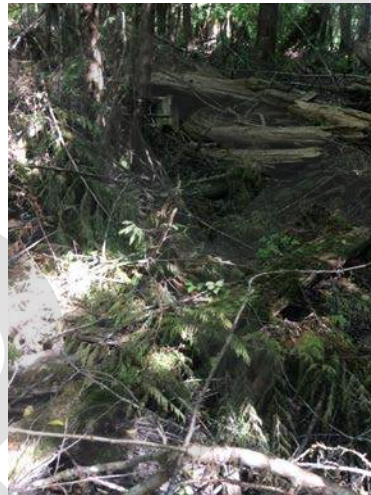
Figure 13: LWM accumulation

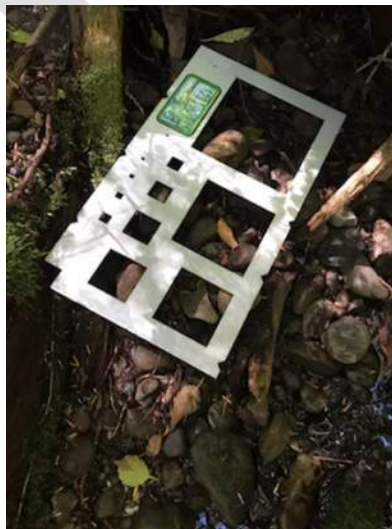
Past the logging wood at the exit of the pool, there is a large deposit of gravels and cobbles (Figure 14). The largest bed material found in this location was 4.5 inches in diameter. The substrate from this deposit up until the culvert inlet is primarily gravels. From this spot to the culvert approximately 50 feet away, LWM recruited naturally from the banks is present in the channel and lying across bankfull (Figure 15). The channel shape in this area consists of short vertical banks that slope up towards a flat floodplain. The banks are undercut in the proximity of the culvert (Figure 16). Natural logs shore up the banks in the stretch between the racked-up logging wood and the culvert. On the right bank near the culvert, a small side channel enters the channel. It likely carries floodplain flow from upstream to this location. There is LWM present in the side channel.

Figure 14: Substrate downstream of LWM

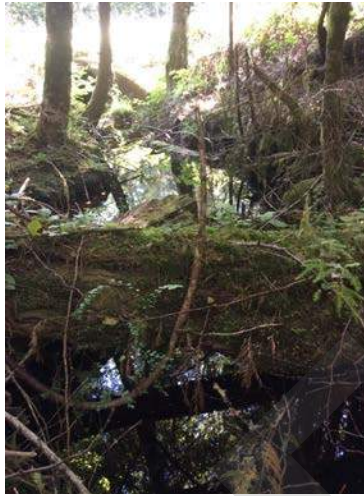
Figure 15: Stream conditions between LWM and inlet

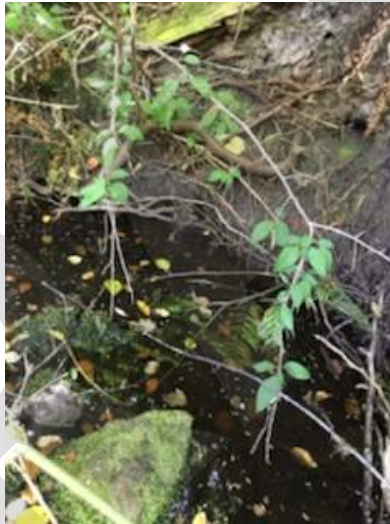
Figure 16: Incision near culvert inlet

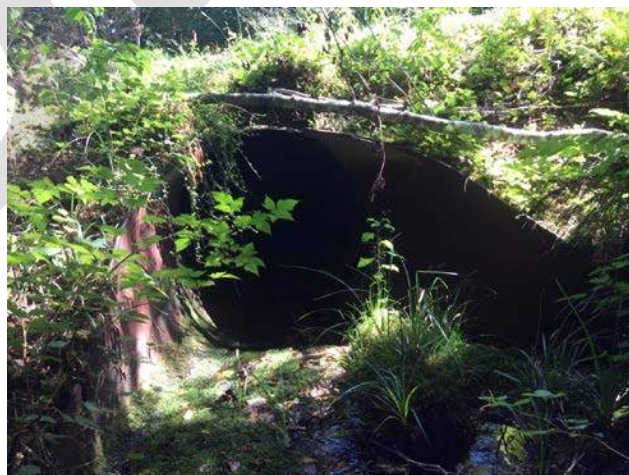
The culvert itself is a 4 foot wide CMP mitered to slope (Figure 17). The culvert inlet is perched approximately 4 inches above the channel bed.

Figure 17: Culvert inlet

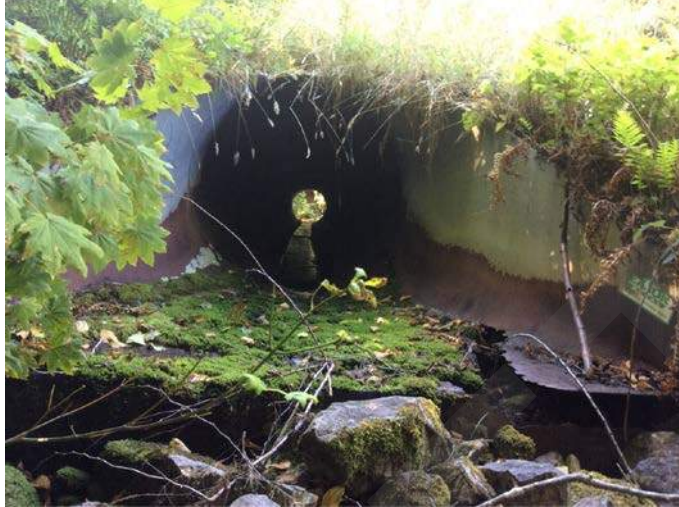
At the outlet of the culvert, the water level drops approximately 6 inches on to rip rap (Figure 18). Rip rap is present in the channel for 15 feet downstream of the culvert. The right bank is about 3-4 feet tall, while the left bank is lower with an accessible floodplain. Stands of trees and ferns grow on the banks. Some undercutting of the channel bank is present at a bend downstream of the rip rap. Small debris and brush is racked up after this bend; throughout the whole of the downstream reach, all LWM observed appears to be a result of natural recruitment along the banks and was not indicative of logging presence (Figure 19).

Figure 18: Culvert outlet

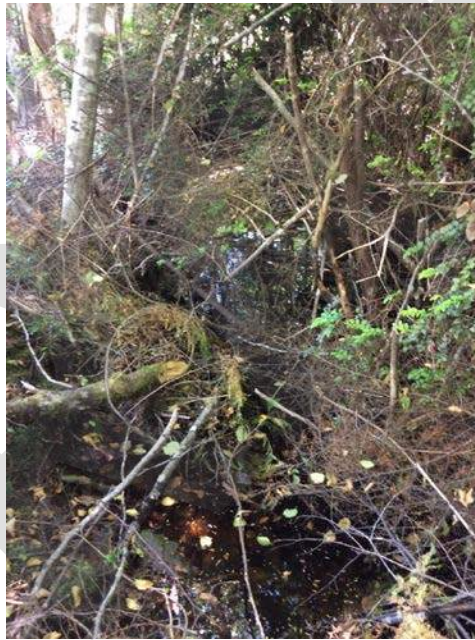
Figure 19: Brush in channel

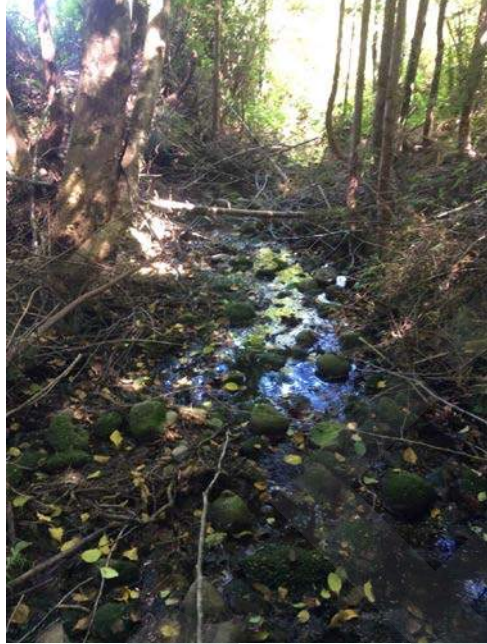
Downstream of the LWM racking, the reference reach begins (Figure 20). The left bank is slightly lower than the right, about 1-2 feet tall while the right bank is about 2-3 feet tall. The left bank floodplain is flat before sloping up to the roadway. The right floodplain is sloped. Roots of trees form the banks periodically on both banks. The channel itself is wide and flat, with no clear thalweg. All three bankfull widths were taken through this section of stream (Figure 21, Figure 22, and Figure 23). The channel substrate is gravels and cobbles, and a pebble count was performed here as well (Figure 24 and Figure 25). Trees are present on the banks and in the floodplains but there is little brush.

Figure 20: Reference reach

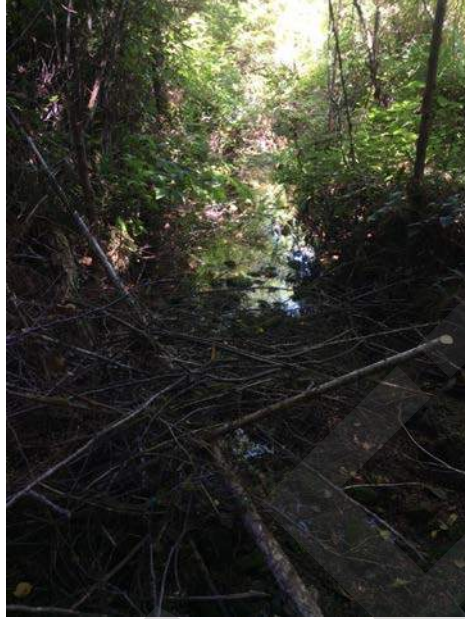
Downstream of the reference reach, the channel shape changes to become narrower and deeper with inaccessible floodplains (Figure 26). Both banks are 3-4 feet in height and show signs of erosion due to channel incision (Figure 27). The banks are vegetated with brush and trees, and the substrate is gravels and cobbles. Approximately 30 feet before the end of the survey extents, there is a 6 inch water drop over sedges and sediment present in the channel (Figure 28). At the very downstream end of the survey, the channel changes shape again to become wetland-like. Sedges are present in the channel.

Figure 26: Typical channel conditions downstream of reference reach

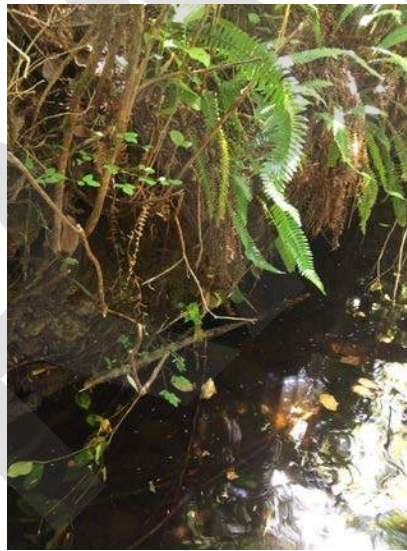
Figure 27: Channel incising and undercut bank

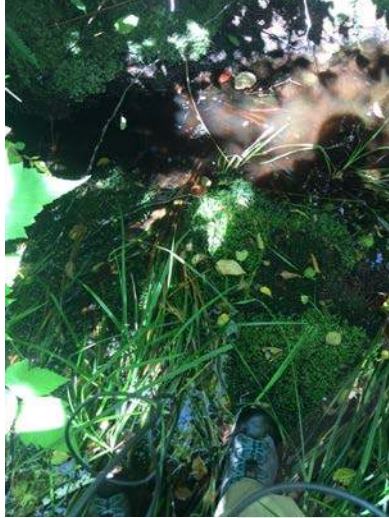
Figure 28: WS drop over sedge

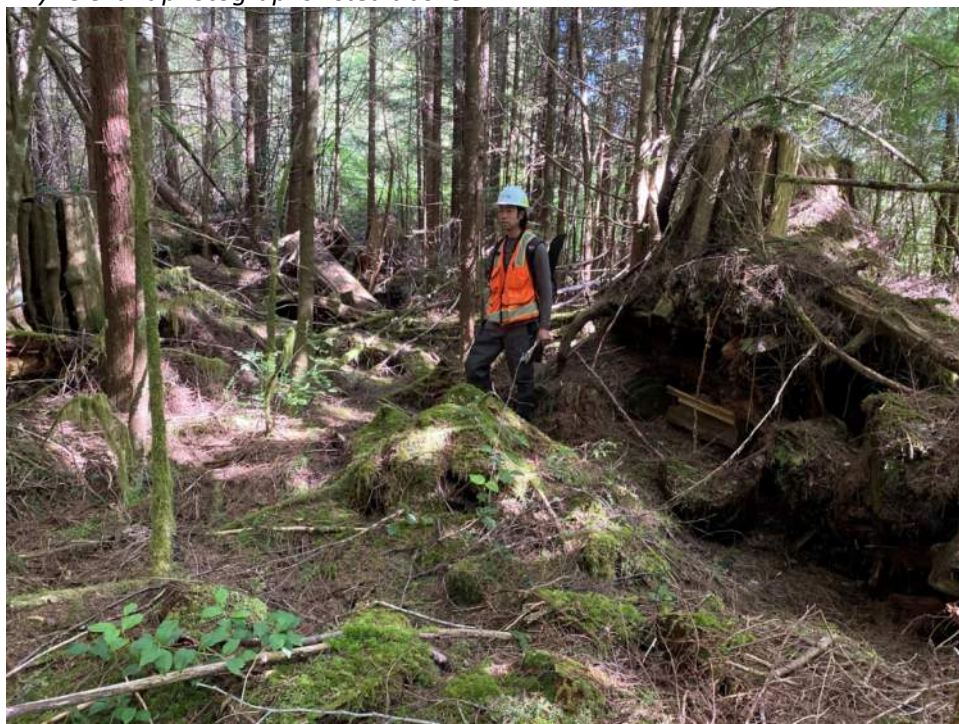
The channel upstream of the culvert is characterized by multiple flow paths throughout an undulating mat formed by wood debris, slash, and blowdown. Flow disappears subsurface in areas. Conifers are growing throughout the area on nurse logs further splitting low flow channels. The local substrate is predominately clay with small, isolated gravel deposits downstream of large wood accumulations, which are plentiful. Confinement of the channel at the culvert inlet is likely driving local bank erosion, though the upstream reach appears relatively stable. Habitat conditions upstream of the culvert are best characterized as primarily rearing habitat with limited to no spawning opportunities. A potential site for realignment of Harlow Creek was investigated in the field, which follows a downhill gradient through a dense stand of young confers on the west side of Highway 101 (Figure 1). Field observations of compatible habitat features, potential conveyance, overall topography, connectivity to existing up- and downstream gradients, and constructability allow the potential realignment site to be feasible for additional consideration. There is insufficient data, particularly a lack of topography, to determine feasibility of a channel realignment at this time.

Figure 1. Potential realignment site for Harlow Creek, located west of Highway 101 looking down-gradient.

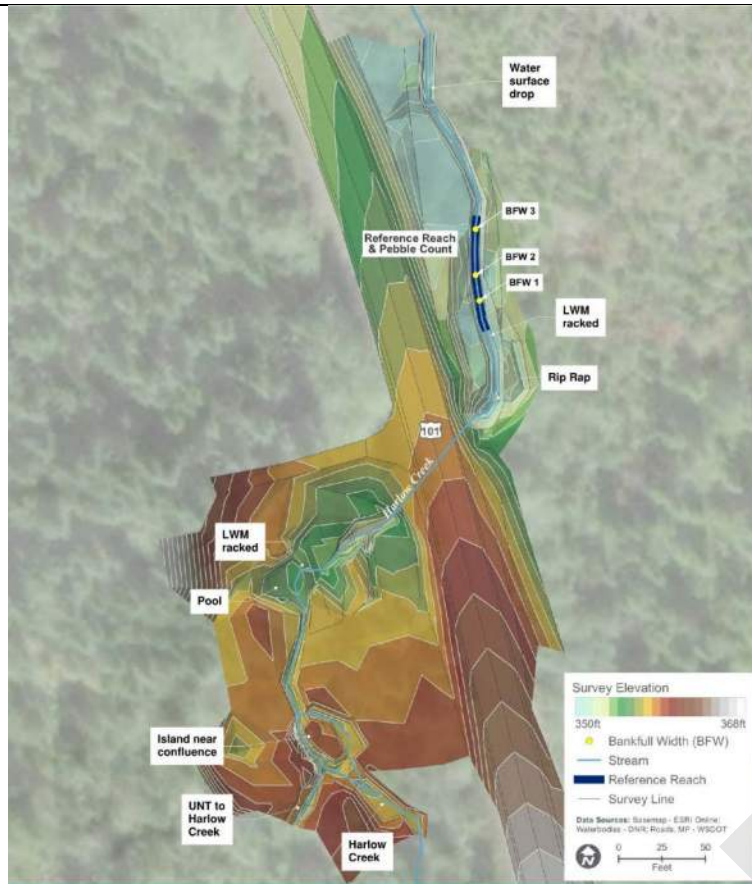
Downstream of the culvert the channel makes a 90-degree turn left with active bank erosion on the right bank, prior to entering the reference reach (Figure 2). Once in the reference reach, the plane bed channel has a cobble gravel substrate and is entrenched and channelized. The bed appears relatively stable, and armored given vegetation that has established on the substrate. Further downstream, the channel entrenches more deeply, with bank heights exceeding 3 ft, but has deep runs and some pools (>3 ft) created by instream wood.

Figure 2. Map of surveyed channel topography by HDR (2020). Flow direction from bottom to top of figure.
